Holcim Australia SHE Alert #350: Date 26/10/2010

Title of Alert	De-dagging
SHE Standard Element	3.15 De-dagging Agitators
Distribution	All Concrete, Humes and Western Region
Date of Incident:	Place of Incident: Boulder Concrete

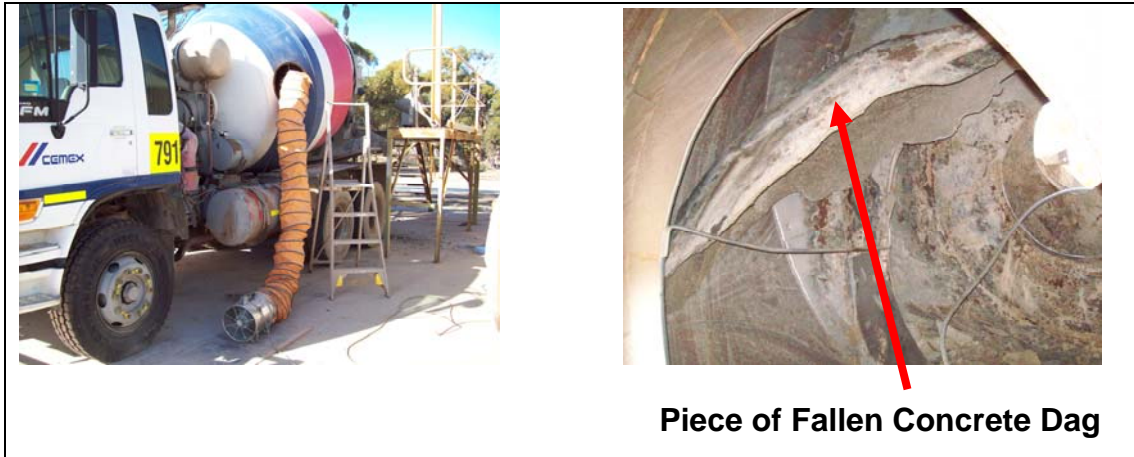
Piece of Fallen Concrete Dag

A Holcim employee was in the process of de-dagging an agitator barrel. He had de-dagged the lower end of the barrel and had started to apply the jack hammer between the fin and concrete below waist height when a large piece of concrete between fins 2 and 3 slid from position. This large piece of concrete initially hit the employee on his head and then became wedged on a bracing bar simultaneously impacting the employee's left hand which was on the bracing for support. The employee suffered a severe injury to his left hand requiring surgery and ongoing rehabilitation.

The investigation revealed that the requirements of the SHE Standard were followed including all training (de-dagging, confined space), permit completion, isolation, emergency preparation etc. The characteristics of the fallen concrete indicate possible inadequate previous wash out practices.

- Temporary cessation of de-dagging on sites.
- The ongoing trial of hydro jetting methods for de-dagging that eliminate the requirement for persons to enter the barrel.
- The adoption of the Ready Jet method for the majority of all future site based de-dagging within Western Region. Refer <http://readyjet.com.au/>
